CALIFORNIA DIVISION OF MINES AND GEOLOGY

FAULT EVALUATION REPORT FER-111

Maacama fault, (Ukiah and Willits segments).

Mendocino County; Ukiah, Elledge Peak, and Willits NE 7.5-minute quadrangles (see Figure 1).

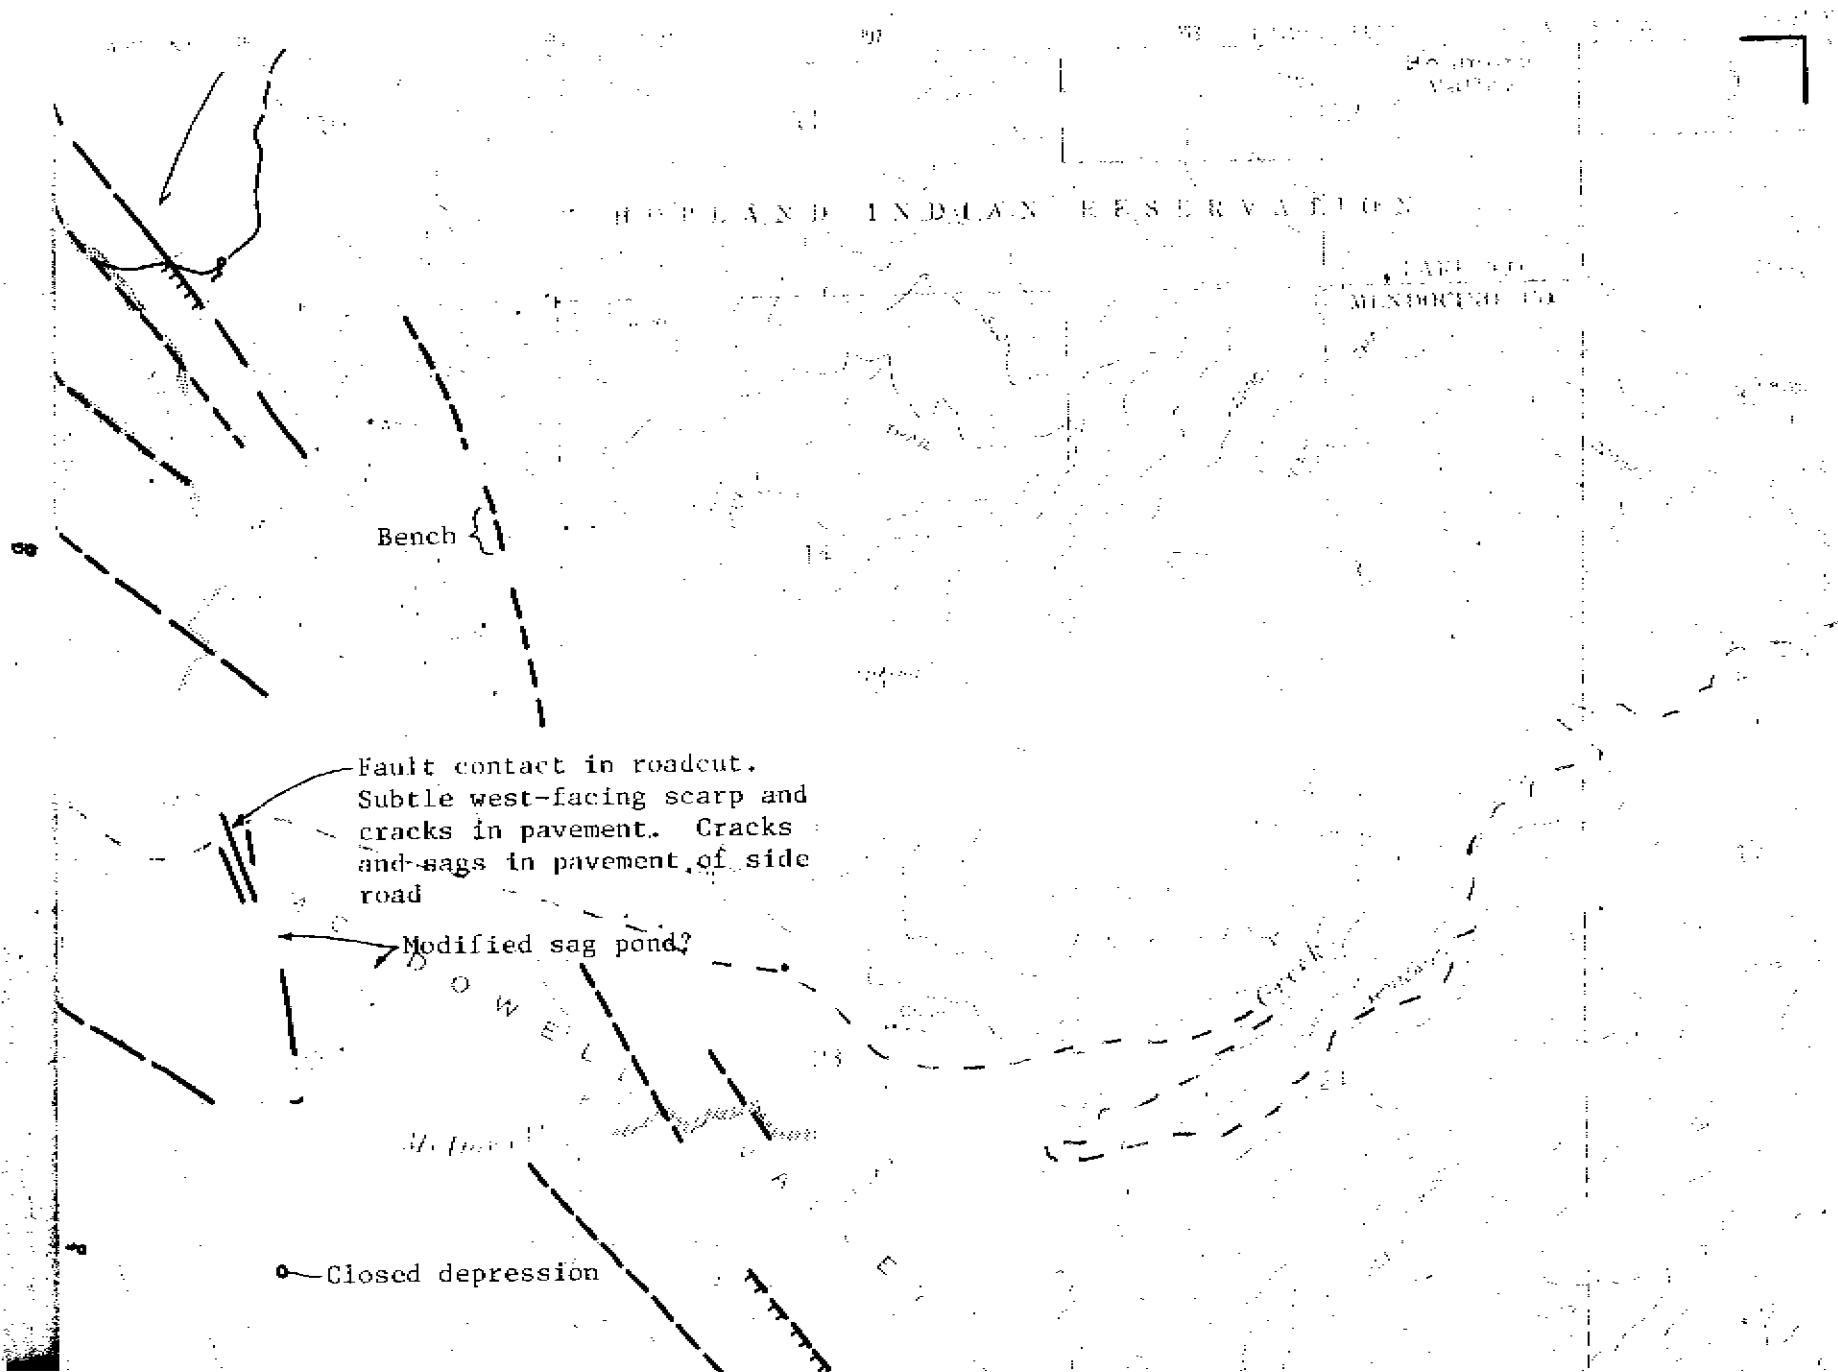
Pampeyan, et al.(1980), imply, but do not directly state, that the features at site A may be the result of fault creep. In addition to the annotations on the map (Figure 3), their text (p. 16) indicates the cracks referred to are aligned with the subtle, west-facing scarp and a fault exposed in a roadcut.

On January 14, 1981, I visited the site. No cracks could be detected in the pavement of State Highway 175. The roadcut had sufficiently failed that no fault was clearly exposed; however, it may be that a fault exists beneath the collapsed materials. Cracks and sags were present in the pavement of the unnamed sideroad. However, the trend of the en echelon cracks, as well as the sags, and the predominant trend of all the cracks observed, was slightly curvilinear and perpendicular to the trend of the fault depicted in Figure 3. Numerous right-stepping fractures, parallel to the road, were observed, and the slope below the road was steep and planar suggesting the road was partly built on fill. No fractures consistent with right-lateral fault creep on the fault depicted could be found. Thus, it appears (90% confidence level) that these cracks are due to subsidence (or a minor slope failure) and not fault creep. Further evaluation of the features in this area is, therefore, deferred until the 1981-

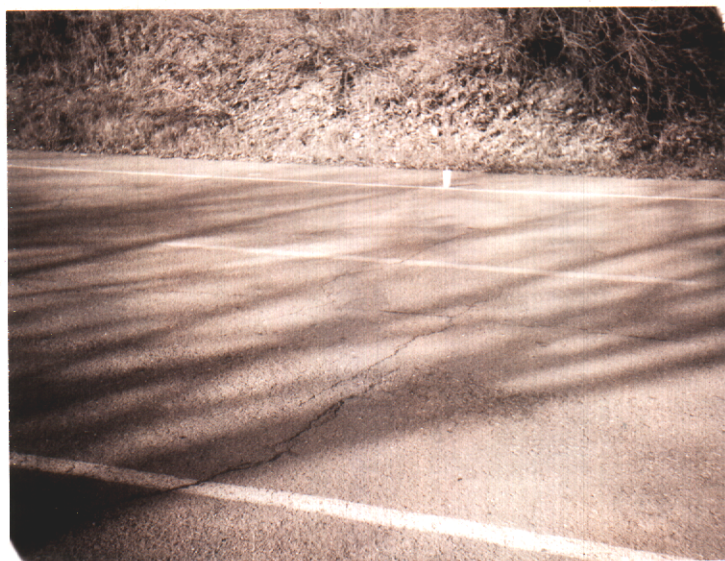
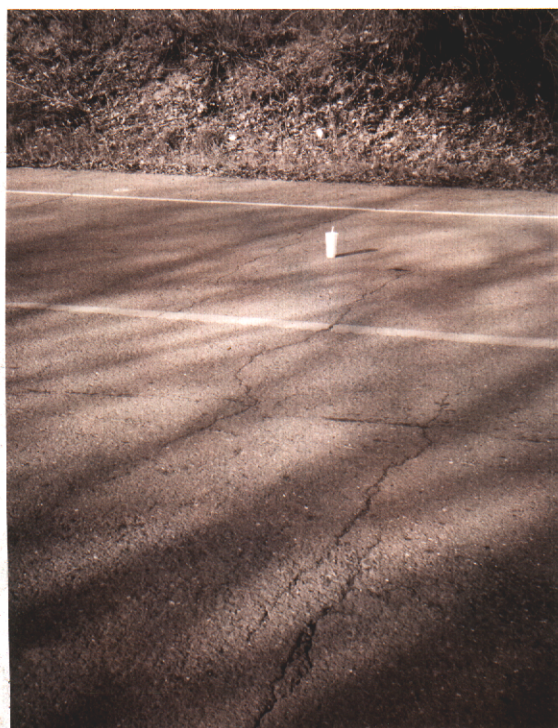
Photo 1. Sanford Ranch Road just south of Regina Heights showing left-stepping, en echelon fractures (northern creep site of Pampeyan, et al (1980) in the Talmage area). Looking north.

Photo 2. Another view of the site shown in Photo 1, showing the left-stepping pattern.

- U-4. A narrow zone of 8 left-stepping, en echelon cracks across Sanford Ranch Road on trend with a fault scarp (to the south), additional zones of cracked pavement, and an offset fence. (A quality) (see Photos 1 and 2).

tures were clearly visible in a narrow zone crossing the roadway (see Photos 1 and 2). Pampeyan, et al., report that they have measured creep at a rate of 1 mm per year at this location.

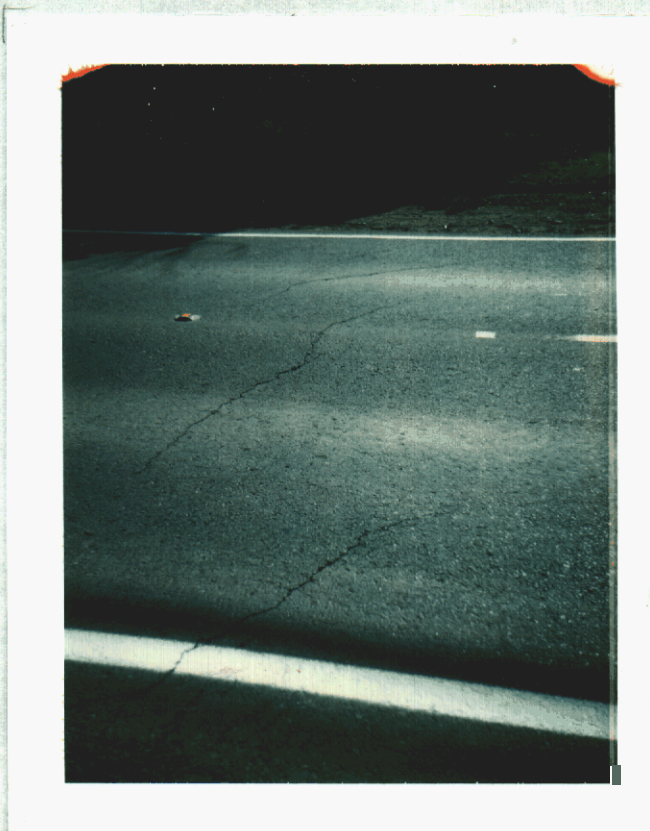
- U-1. On Lake Mendocino Avenue about 400 feet west of Coyote Dam there is a zone of left-stepping, en echelon fractures in the pavement adjacent to and on trend with a west-facing fault scarp. A slight but abrupt rise in the roadway coincides with the fractures zone, west side up (A-quality*) (see Photo 3).

Photo 3. Left-stepping, en echelon fractures in the pavement of Lake Mendocino Drive, looking north.

On January 14, 1981, I verified the existence of the reported fractures. Not only were left-stepping fractures apparent, but so was a slight rise in the roadway, east side up, consistent with the adjacent escarpment (see Photo 3) Between sites B and C (Figure 4B, Table 1, Loc. ^UN-1).

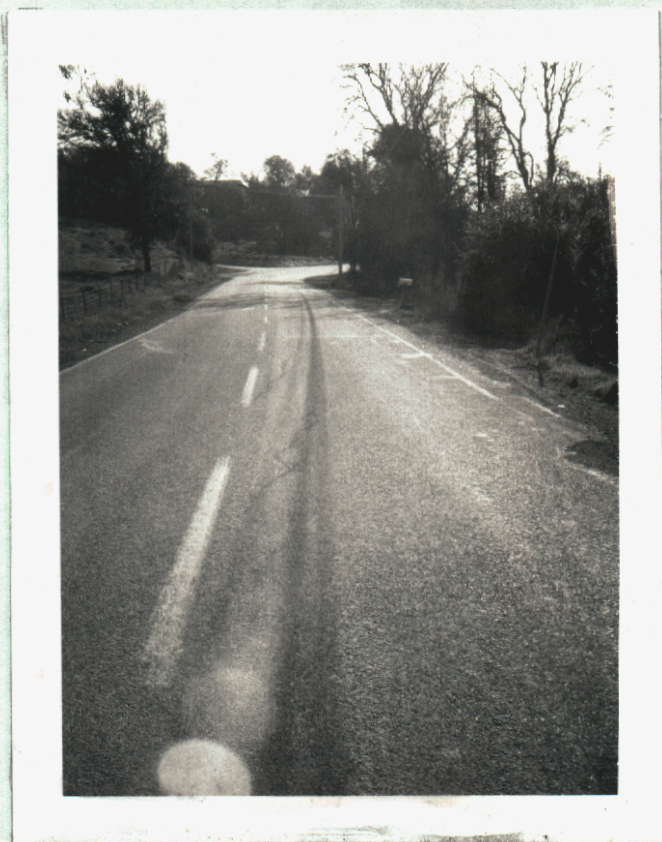
- U-3. On Redemeyer Road just north of El Dorado there is a long zone of left-stepping, en echelon fractures. Adjacent to some of the left-stepping fractures is a series of low compression rolls in old pavement. Three left-stepping fractures were present in a newly paved section of road immediately north of El Dorado. All of these features occur in a single, narrow zone less than 2 feet wide, with, occasionally, long continuous fractures (see Photos 4 through 6) (B-quality).

Photo 4. Left-stepping cracks in Redemeyer Road just north of El Dorado. Looking south.

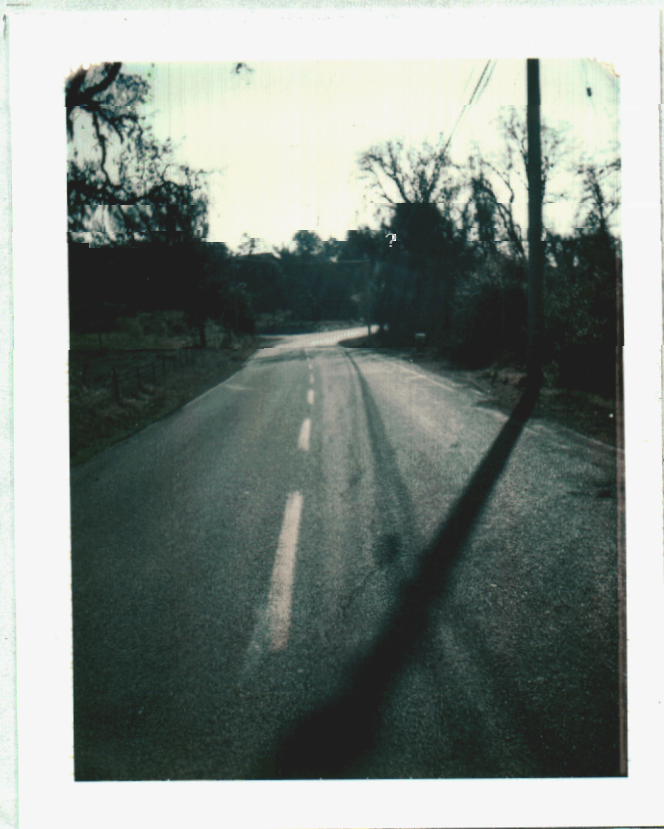
Photo 5. Left-stepping cracks in Redemeyer Road. Location is a few feet south of Photo 4. Looking south.

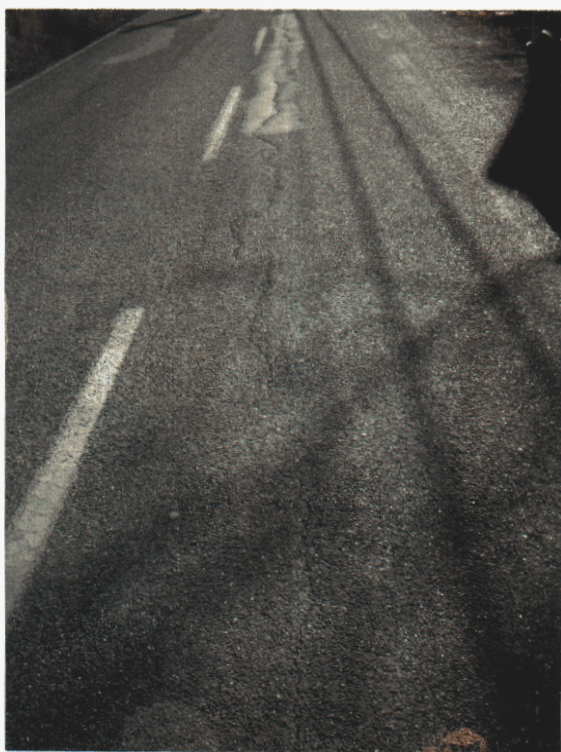
Photo 6. Redemeyer Road, just south of Photo 5, showing some left- stepping cracks trending into a long, continuous crack, looking south.

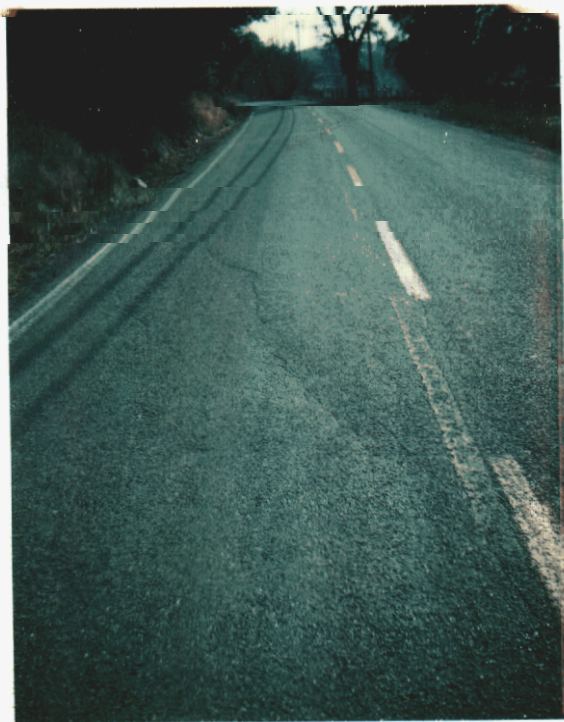
- U-2. On Redemeyer Road approximately 2300 feet north of El Dorado there is a zone of buckled and cracked pavement adjacent to a fault mapped by Pampeyan, et al. (1980) (C-quality) (see Photo 7).

Photo 7. Redemeyer Road, several hundred feet north of the site where Photos "4" - 6 were taken, showing cracks in pavement and subtle bulge. Looking south.

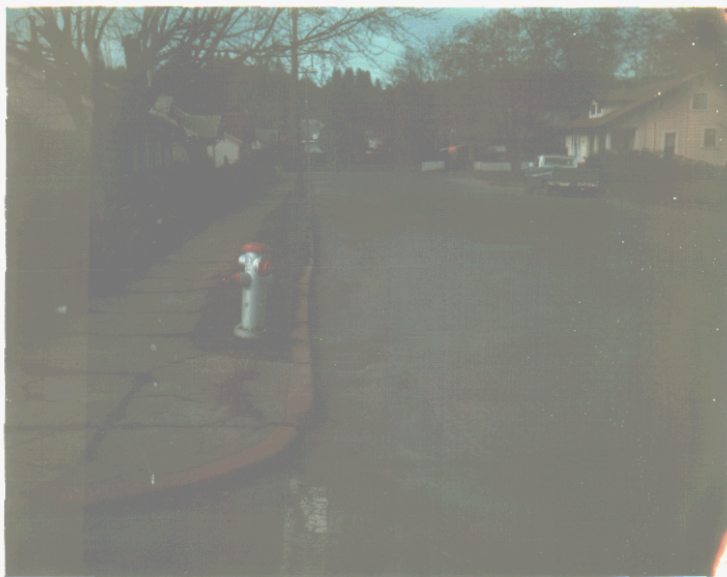
- W-7. Narrow zone of left-stepping, en echelon cracks across West Valley at McKinley. Both curbs and sidewalks are clearly right-laterally offset (see Photos 8 and 9) (A-quality).

Photo 8. The south curb of West Valley at McKinley (Willits) is right-lateraliy offset. En echelon fractures are visible in the pavement trending toward the offset curb (Photo 9, below).

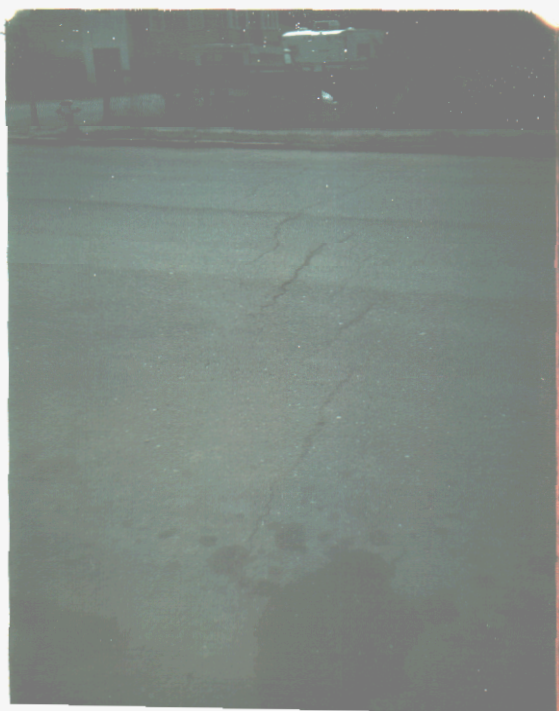
Photo 9. Looking south toward the offset curb shown in Photo 8.

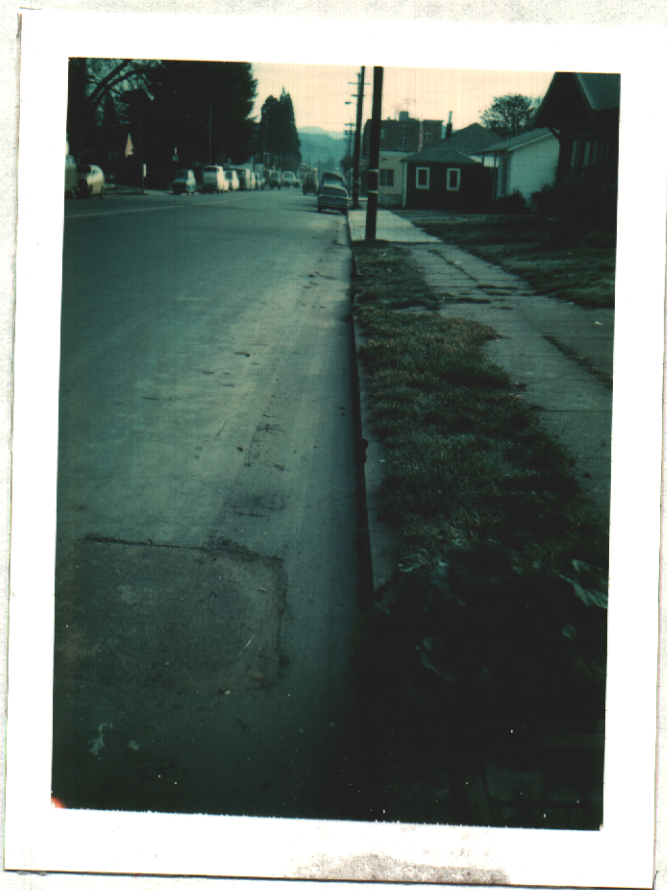
- W-3. South sidewalk and curb of W. Commercial are right-laterally offset (no north curb present), on trend with NW-trending zone of left-stepping fractures in AC pavement (A-quality) (see Photos 10 and 11).

Photo 10. Left-stepping, en echelon fractures in the street in front of 154 W. Commercial, Willits (looking north).

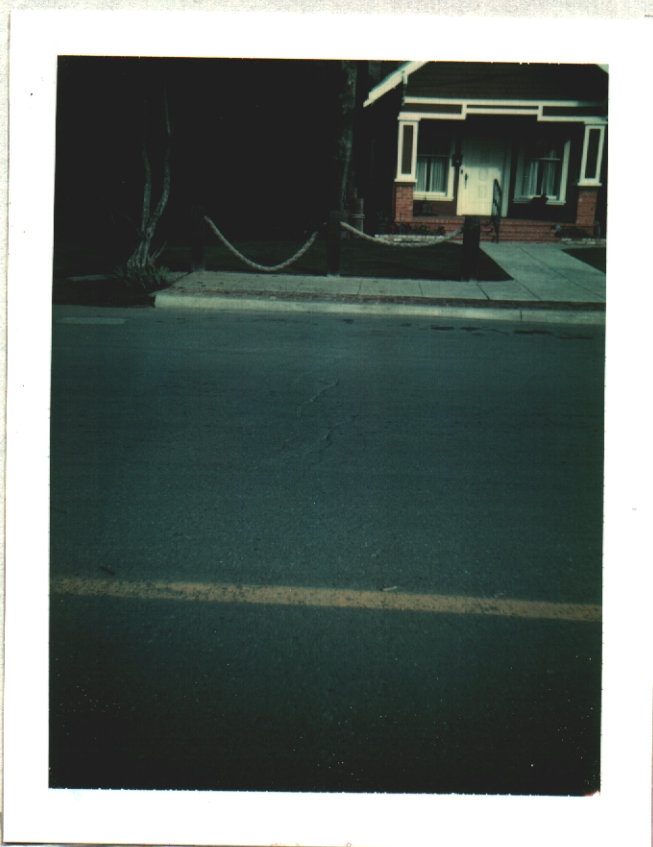
Photo 11. Right-laterally offset curb across the street from 154 W. Commercial, on trend with the fractures shown in Photo 10.

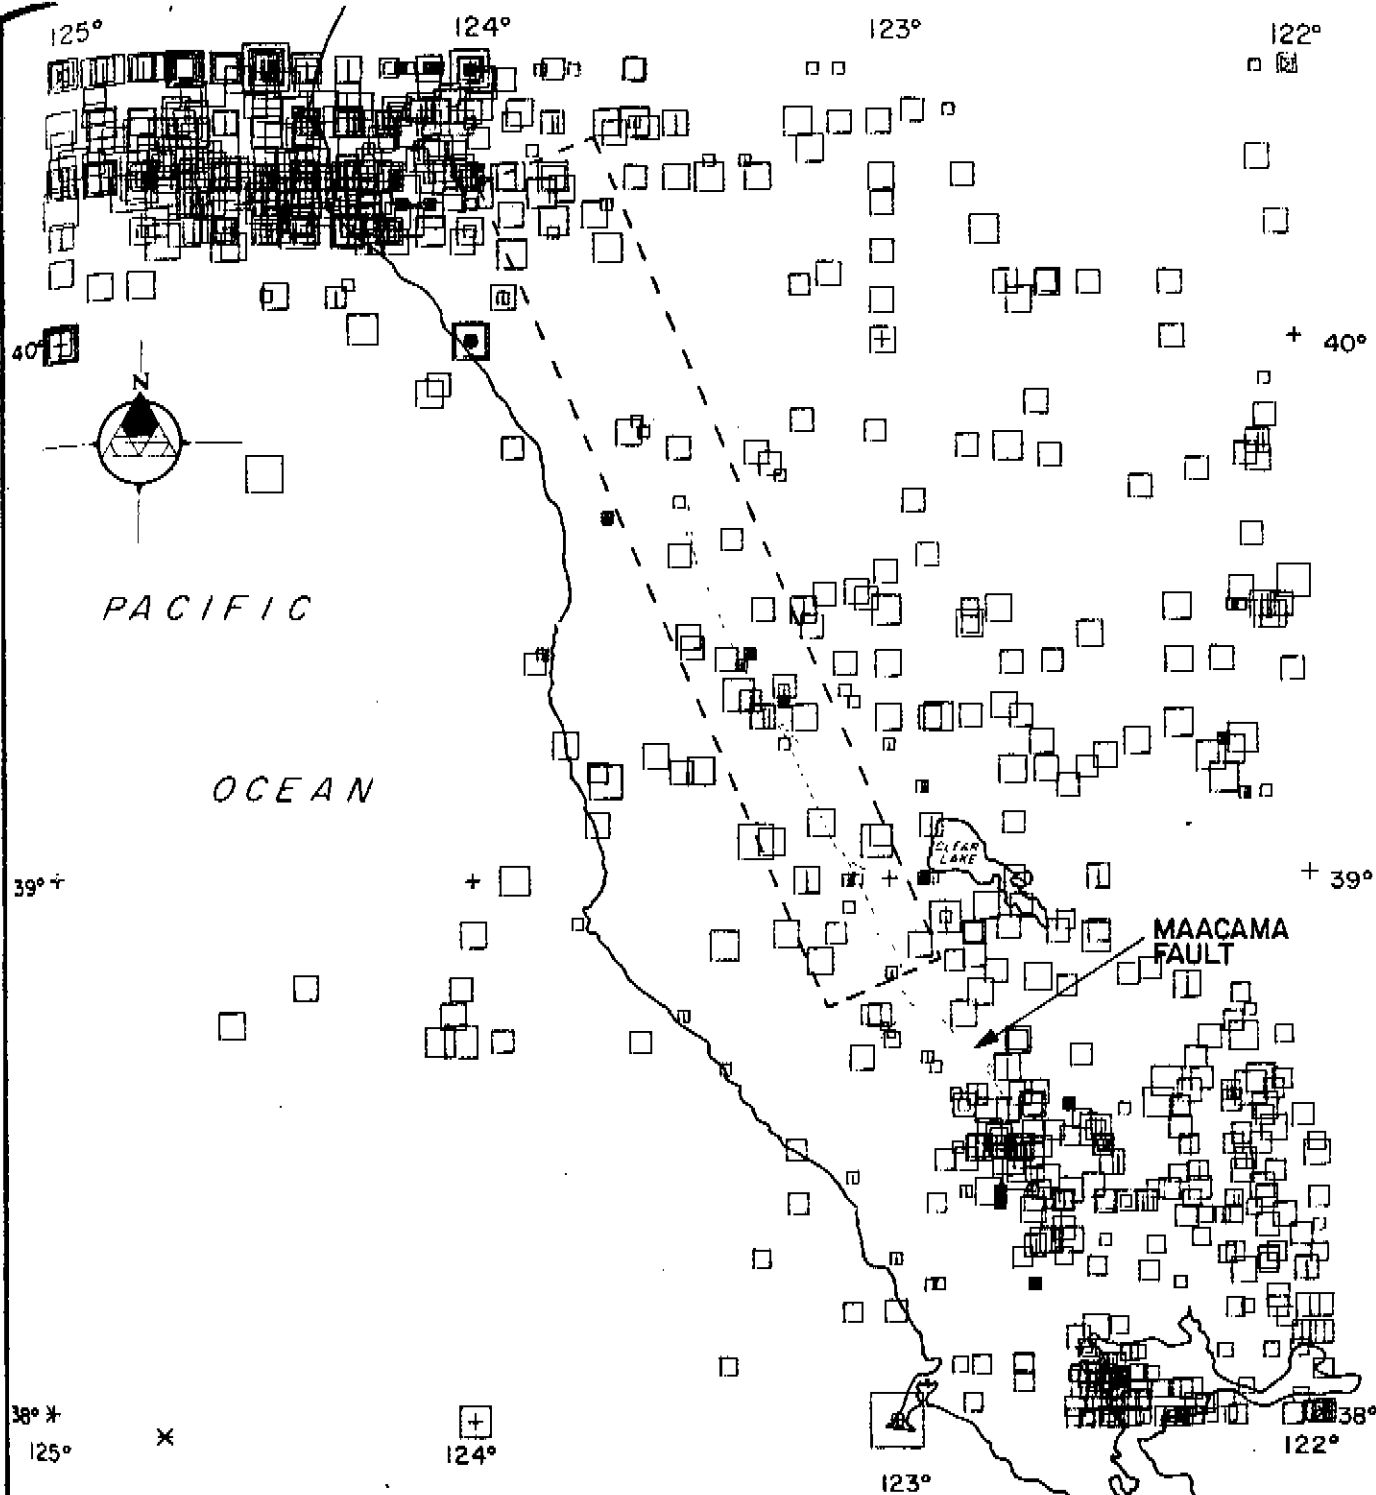
FER III
Figure 5.

The Dames and Moore (1977) study was directed at detecting microearthquakes along the Maacama fault zone. While the seismographic record from 1906 to 1976 does not clearly show a zone of greater seismic activity along the Maacama (see Figure 5), the microseismic survey conducted over a 72-day period ending September 23, 1977, does appear to document seismic activity associated with the Maacama fault. The activity extends along the fault as mapped by Harding-Lawson Associates (1977), and northward about 10 km beyond their northernmost trace. Dames and Moore also noted that the microseismicity seemed to lie slightly east of the mapped trace, and that solutions were consistent with right-lateral, strike-slip movement (see Figures 6 and 7).

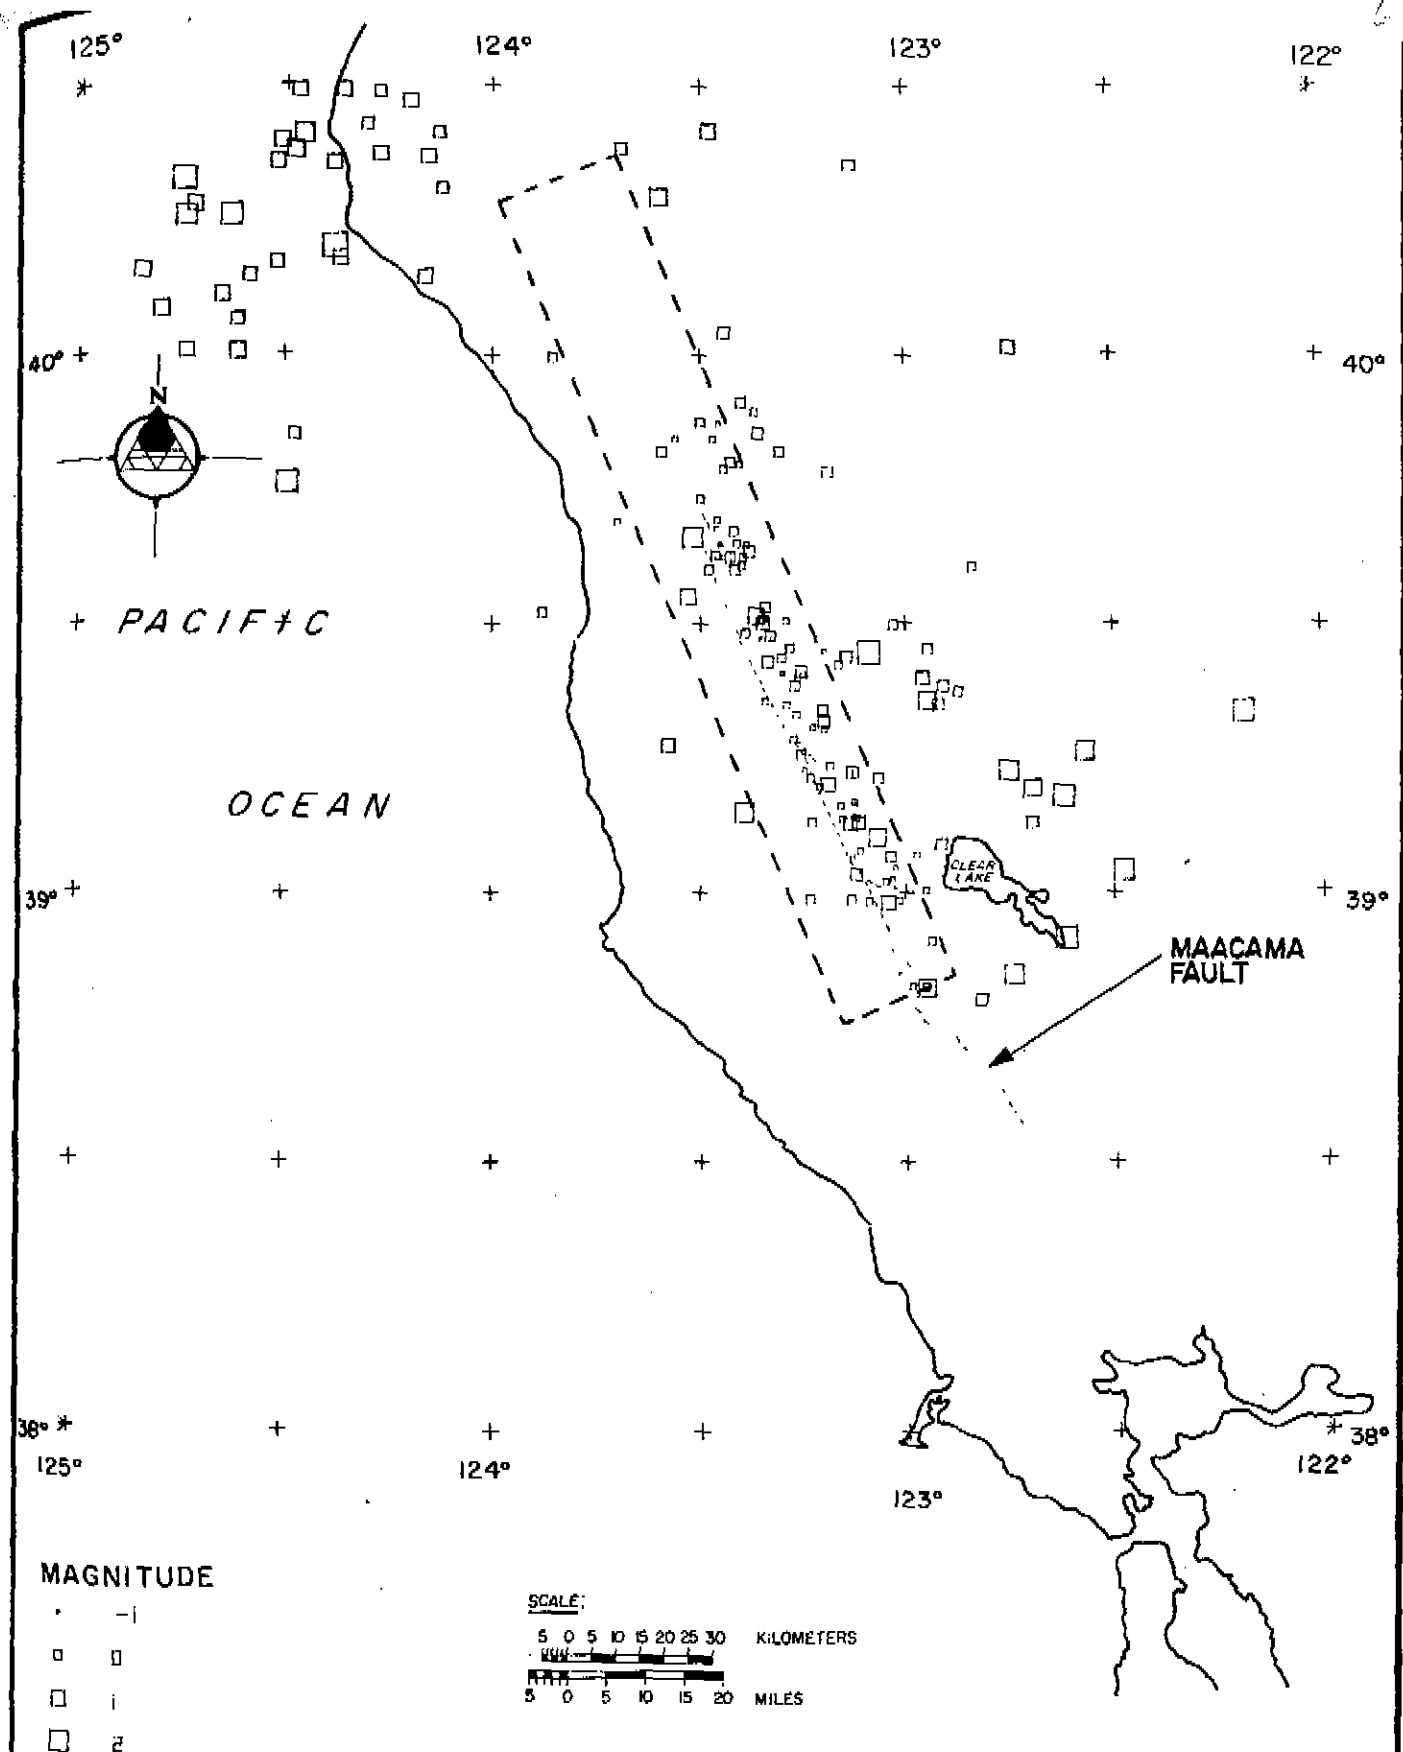
FER III
Figure 6

The Dames and Moore (1977) data strongly suggest that the Maacama fault is seismically active. That most of the epicenters lie east of the fault can be explained if the fault dips eastward, or if the crustal model used
